**2005 Operations, Maintenance,  
and Monitoring Report**

**Sweet Lake/Willow Lake Hydrologic  
Restoration**

State Project Number CS-11b  
Priority Project List 5

June, 2005  
Cameron Parish

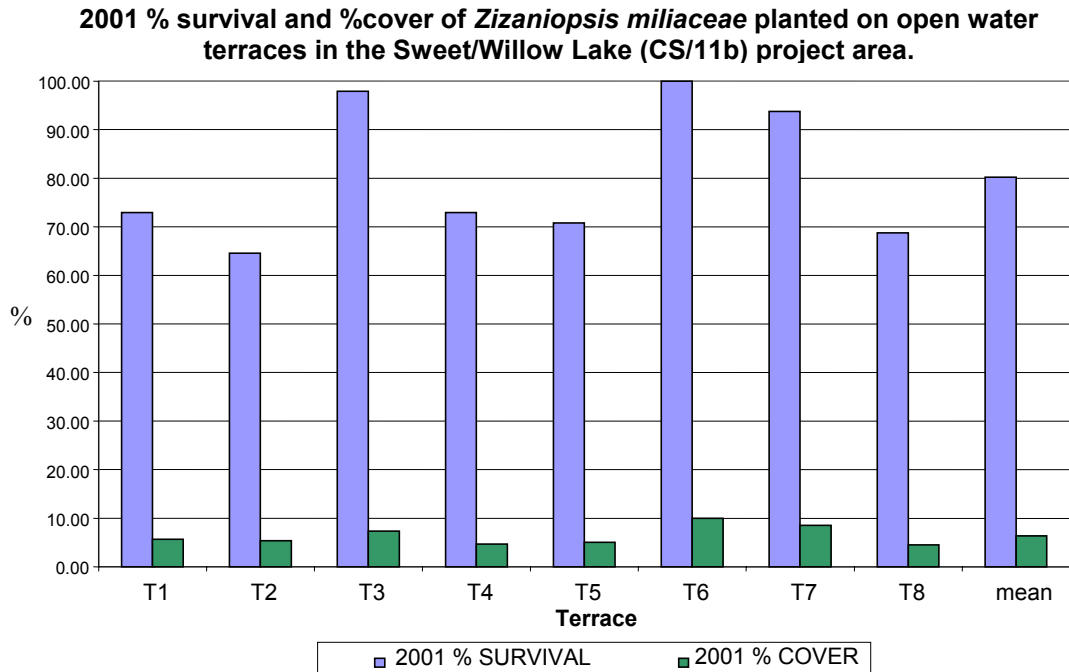
Mean survival of *Z. miliaceae* plantings on the open water terraces north of Sweet Lake decreased from 80.2 % to 33.7 % from 1 month post-planting in December 2001 to 1 year post-planting in November 2002 (figures 6 and 7).

**Figure 6.** Percent survival and percent cover of vegetative plantings on the open water terraces located north of Sweet Lake in the Sweet Lake/Willow Lake Hydrologic Restoration (CS-11b) project area sampled 1 month post-planting in December 2001.

The open water terraces north of Sweet Lake were ineffective at reducing wave energy. The lack of consolidated material and high water events during construction caused the terraces to deteriorate rapidly, leaving little or no subaerial mass to buffer waves. The vegetative plantings installed along the unconsolidated open water terraces did not grow well. The lack of suitable planting medium and rapid terrace deterioration did not allow enough time for the plantings to become established. Further data collection should help to determine if the plantings will ever overcome the poor initial establishment and be effective at binding terrace substrates. No additional planting data was collected in 2004.

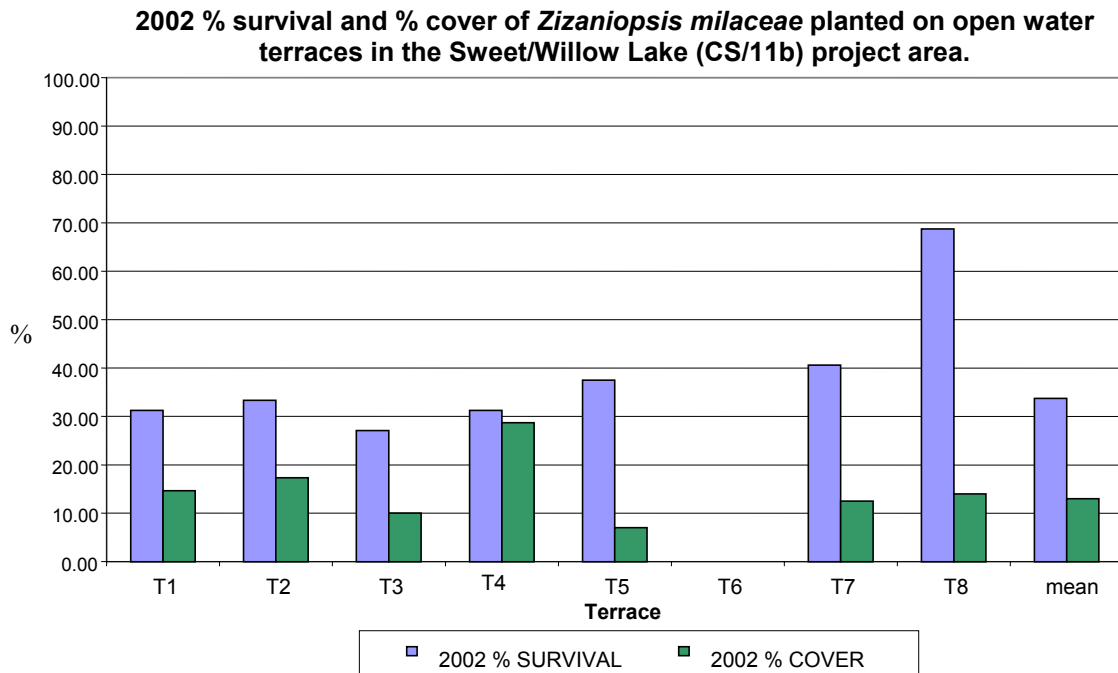
**Figure 7.** Percent survival and percent cover of vegetative plantings on the open water terraces located north of Sweet Lake in the Sweet Lake/Willow Lake Hydrologic Restoration (CS-11b) project area sampled 1 year post-planting in November 2002.

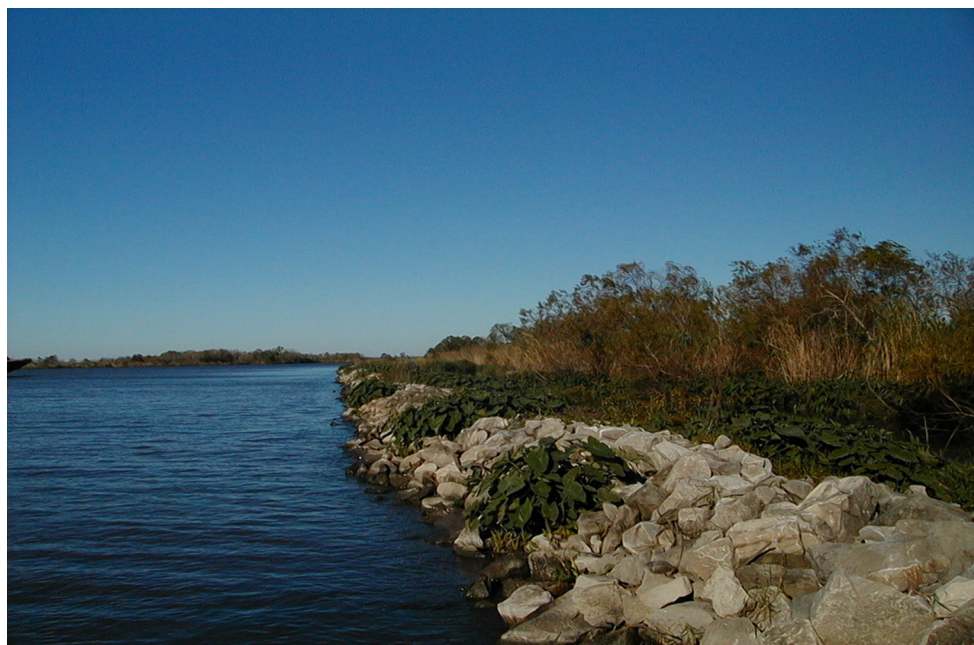
Photo 1—Typical section of dike

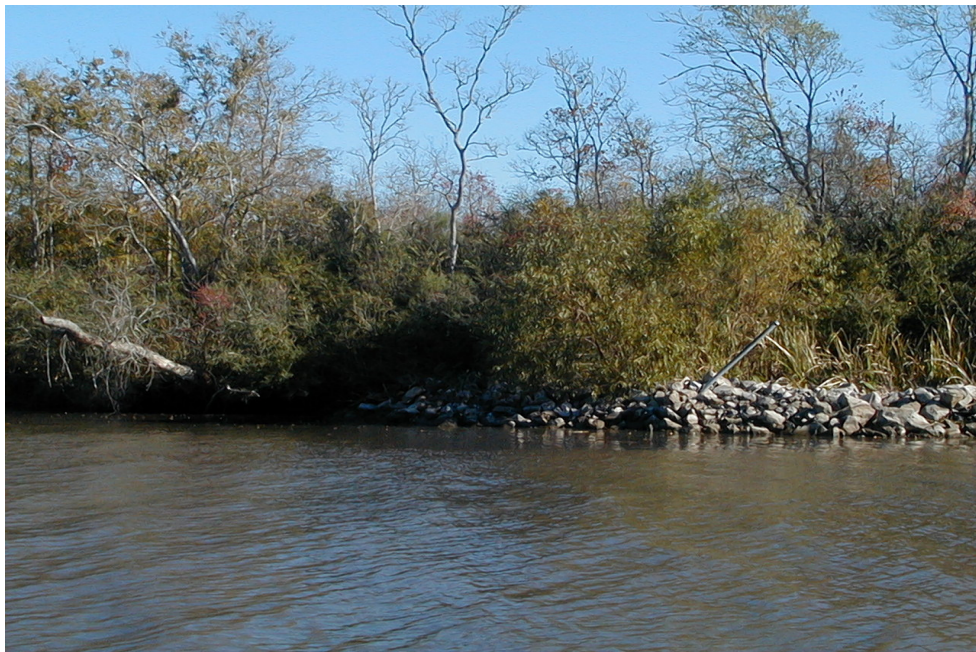
Photo 2—Bank tie-in and leaning settlement plate

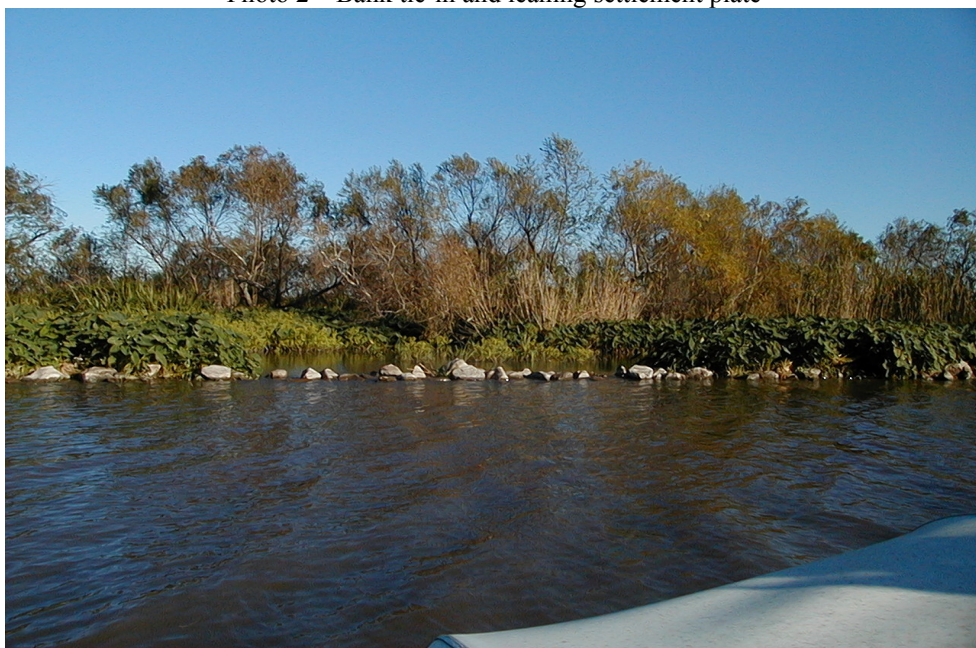
The dikes are in reasonably good condition. There are a few low places along the length of the rock dike, with the most significant stretches along the open water areas adjacent to Sweet Lake. There is an area approximately 50 ft (15.2 m) wide along the very eastern end of the project area in which the dike appears to have been “pushed back” 10-12 ft, (3.0-3.7 m) apparently by a barge. There is another area approximately 4 ft (1.2 m) wide in which the dike appears to have been removed by hunters or fishermen. Several settlement plates are either broken or leaning and are of no use. No gauges were available in the vicinity to determine water levels. The terraces north of Sweet Lake experienced significant erosion.

Photo 3—Low section adjacent to Sweet Lake

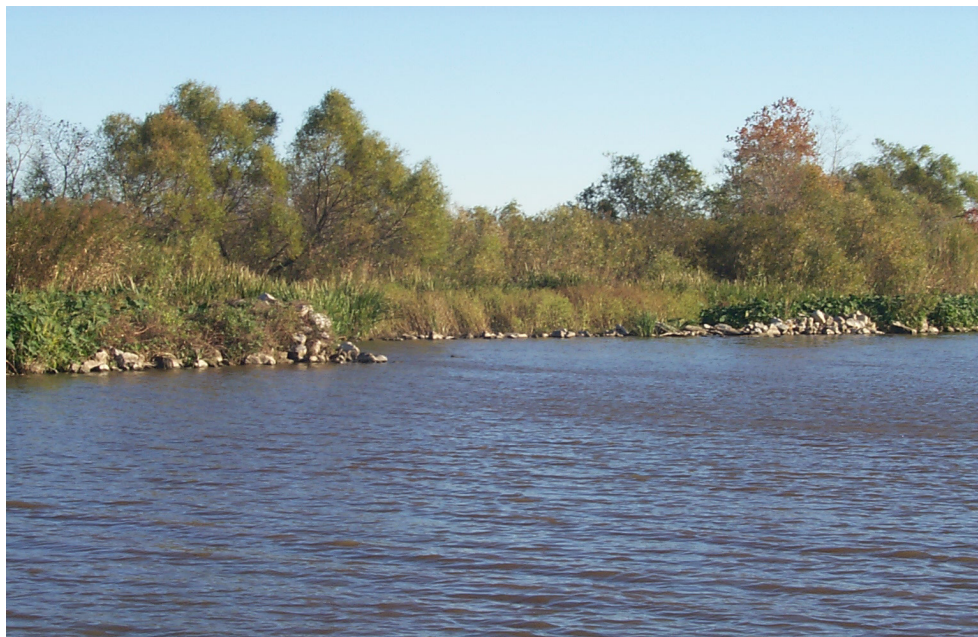
Photo 4—Area of dike displaced by barge

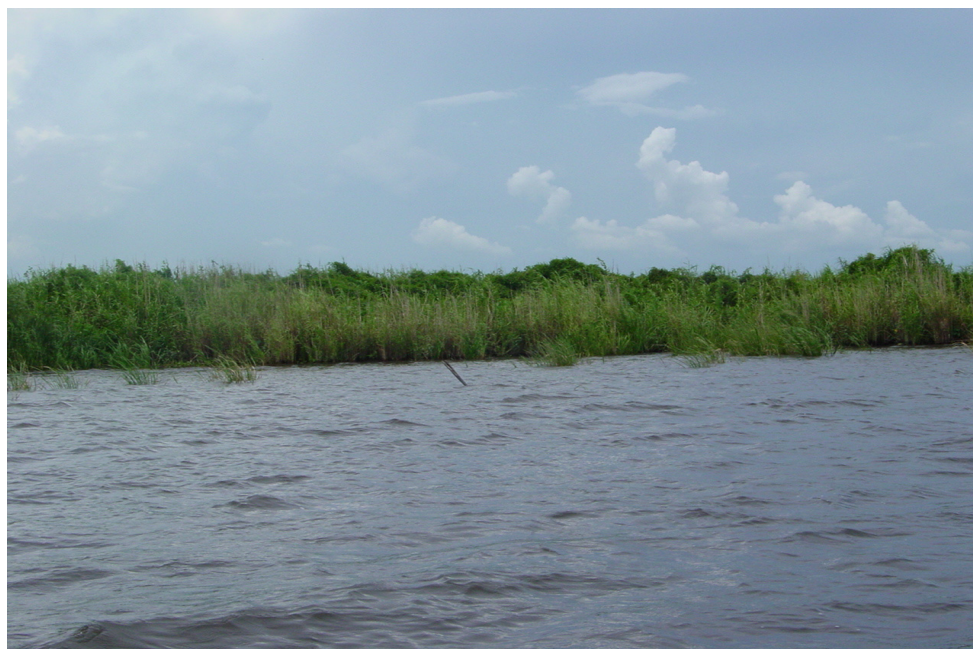
The shoreline terraces in Sweet Lake and Willow Lake were moderately effective at reducing wave energy. High water during construction and the long fetch generated wave erosion, causing the crowns of the terraces to deteriorate until the water levels subsided. Initial data collected for *Z. mileaceae* plantings on the Sweet Lake terraces indicated high but somewhat variable percent survival with low cover values similar to data recorded at 1 month post-construction for the terraces north of Sweet Lake. The percent survival of plantings on the Willow Lake terraces was more consistent and greater than the other plantings. Further data collection will determine if these plantings will be more effective at one year than those on the terraces north of Sweet Lake.

Photo 5—Terrace along Sweet Lake

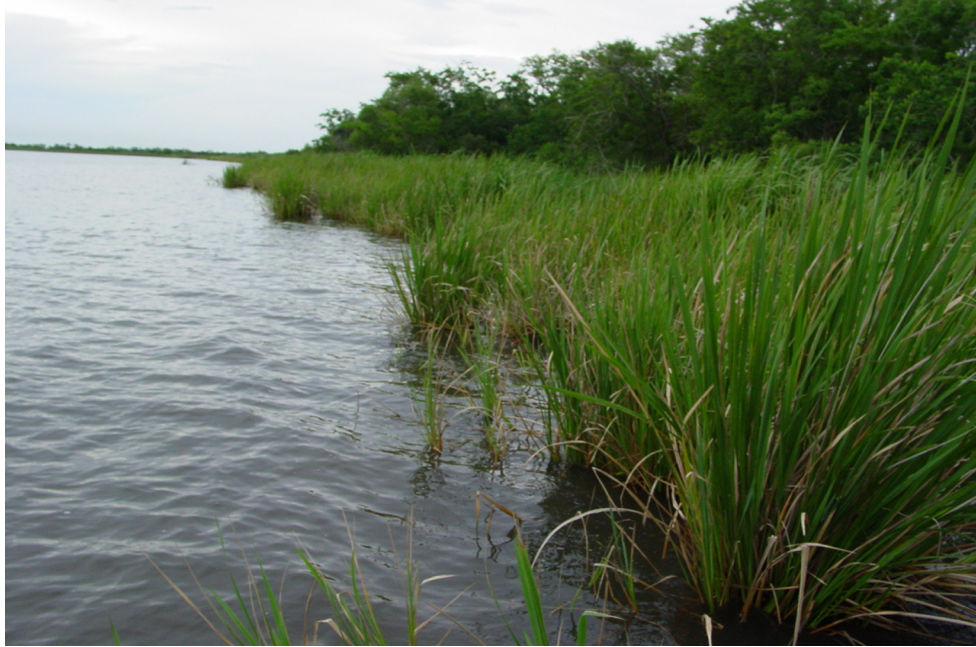
Photo 6—Terrace along Willow Lake
